# **U.S. Aircraft Carriers**

## **in action Part 1**

**By Robert Stern**  
**Color by Don Greer**  
**Illustrated by Joe Sewell**

**Warships Number 5**  
**squadron/signal publications**

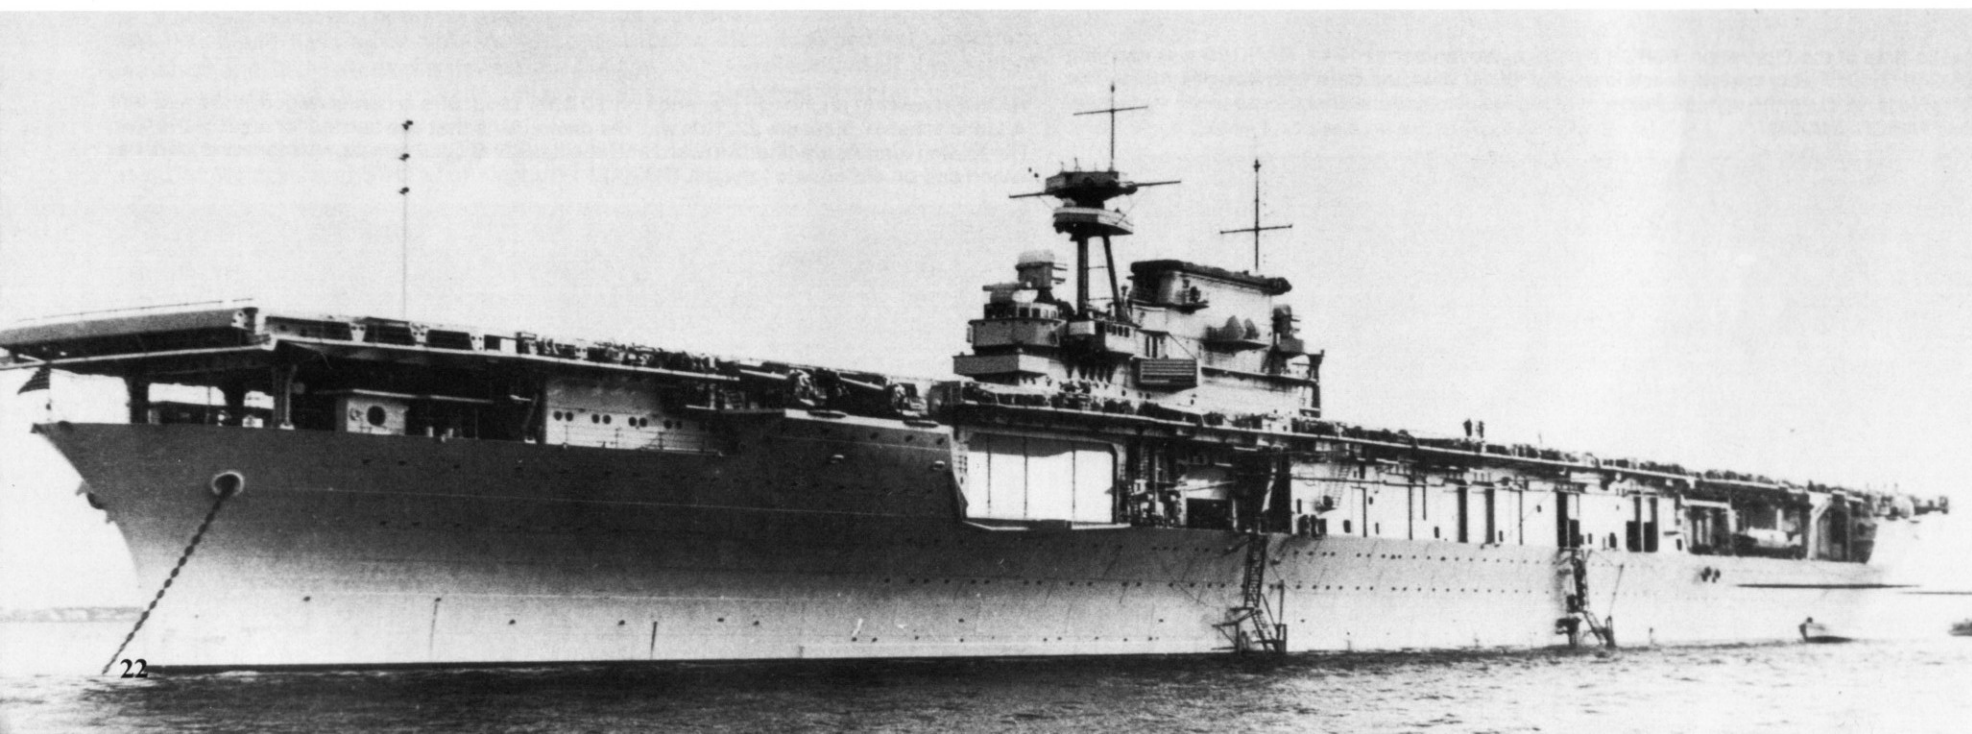
**USS YORKTOWN at anchor at Hampton Roads, Virginia, on 30 October 1937. Like RANGER, she had a large, open hangar deck, equipped with sliding steel shutters that provided weather protection. A gallery deck surrounds the flight deck, even extending under the bow. (NHC)**

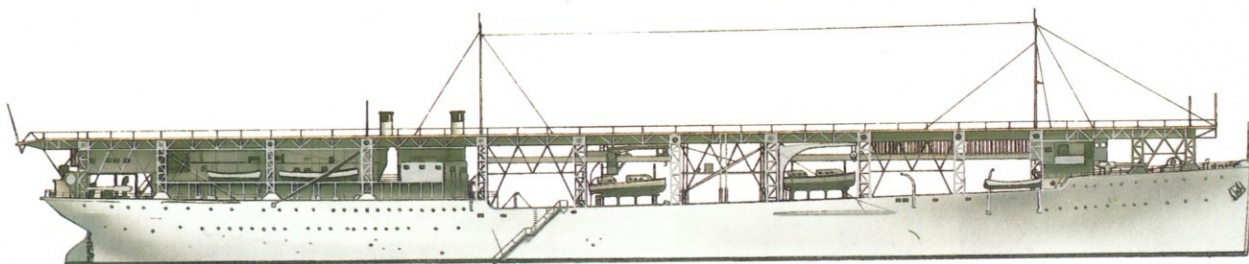
**The USS LANGLEY (CV1) was the U.S. Navy's first aircraft carrier, converted from the collier USS JUPITER.**

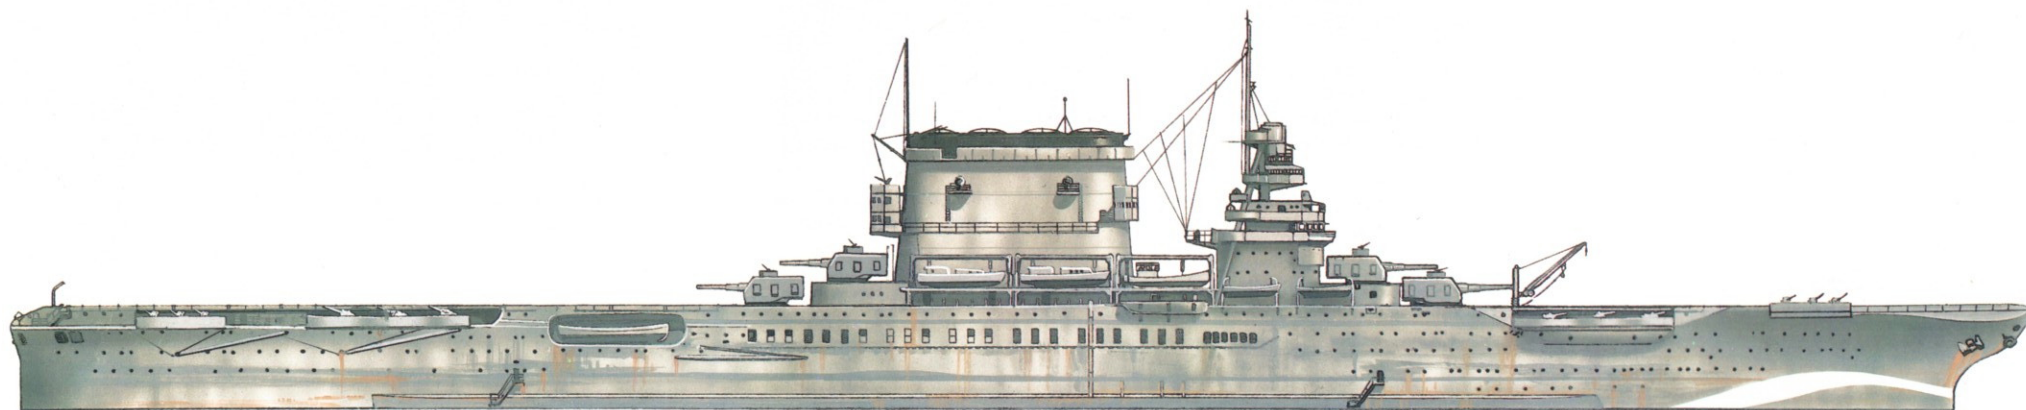
**USS LEXINGTON (CV2) carried a camouflage of Measure 1 (Dark Gray) with a White bow wave during late 1939. The false bow wave gave the impression of high speed even when the ship was dead in the water.**

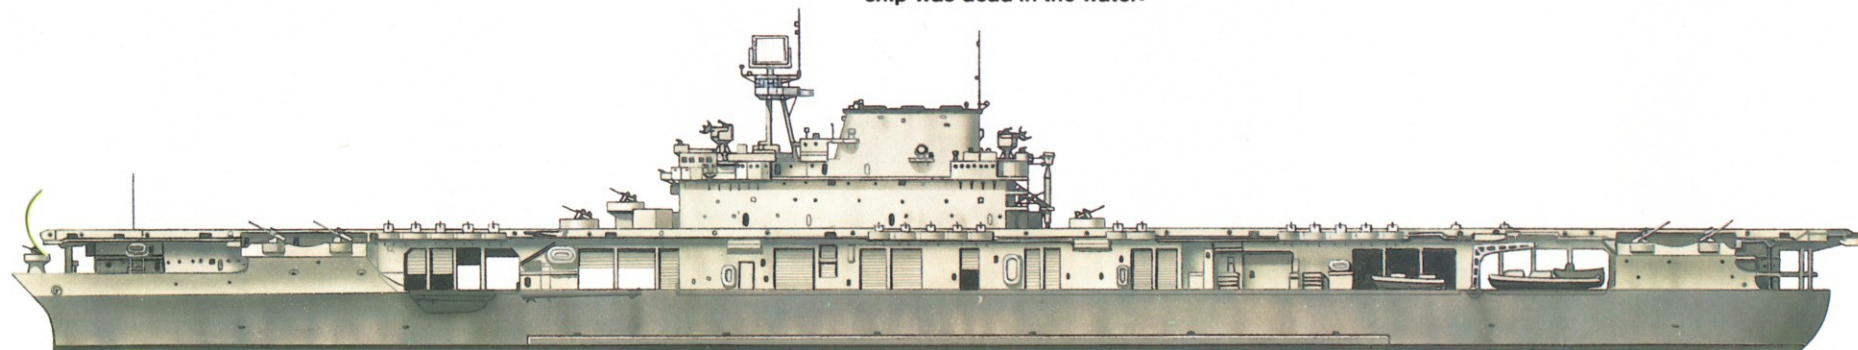
**During early 1942, USS YORKTOWN (CV5) was painted in two tone (Sea Blue and Ocean Gray) Measure 12 camouflage used to make identification and ranging difficult for surface and subsurface opponents.**

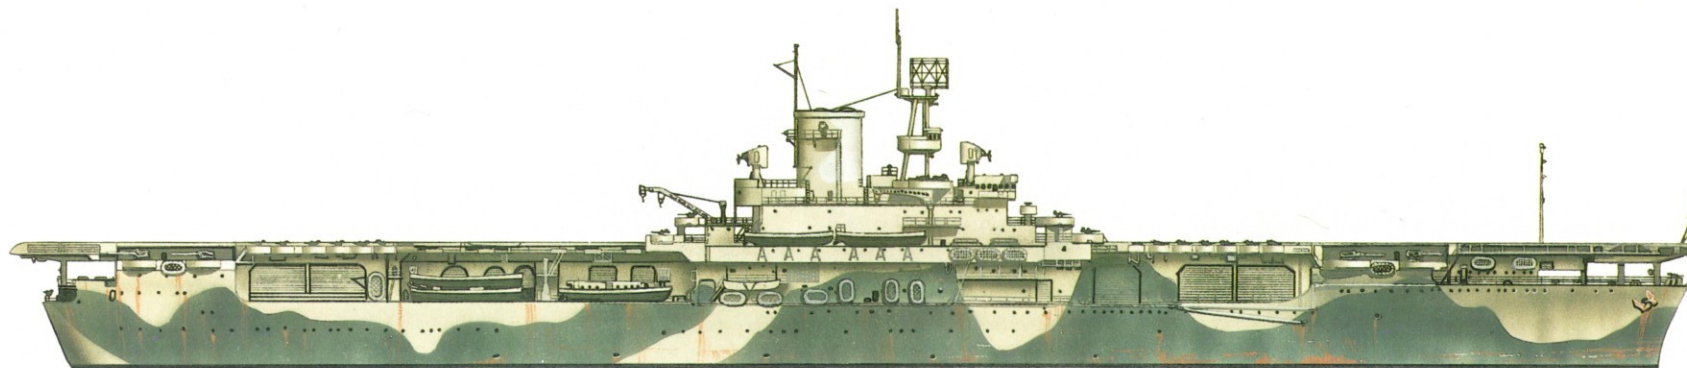
**USS WASP (CV7) carried a Measure 12 Modified camouflage. The wave pattern was intended to make accurate speed and range estimates more difficult for enemy ships.**

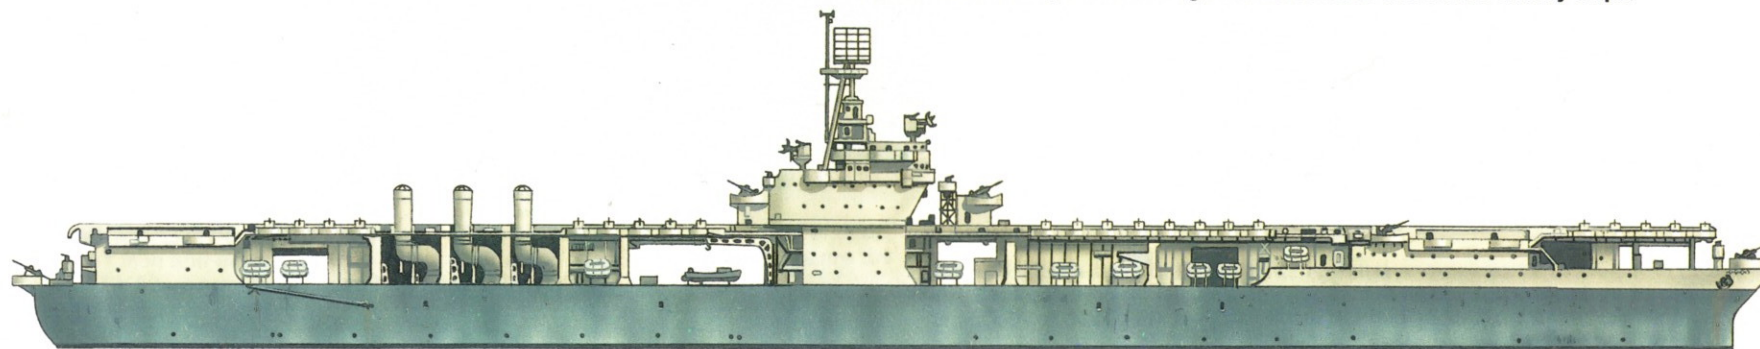
**USS RANGER (CV4) carried Measure 22 (Sea Blue and Haze Gray) camouflage during April of 1943. During this period WASP operated with the British Navy in the Atlantic.**

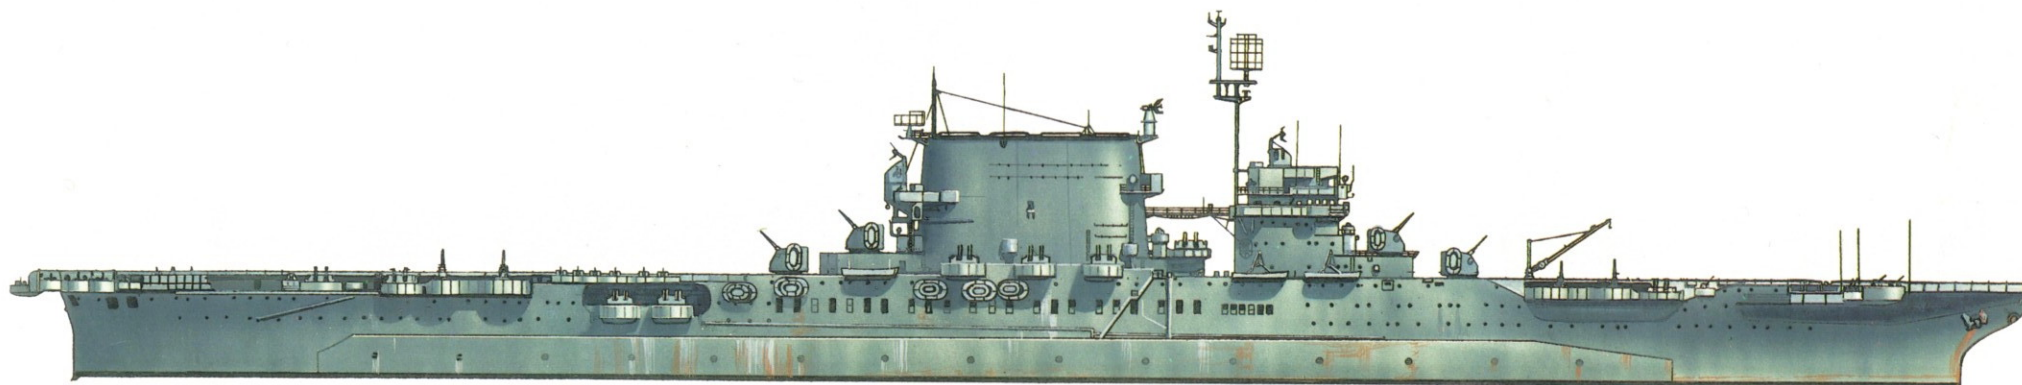
**USS SARATOGA (CV3) carried Measure 21 (Navy Blue) camouflage during 1944. Modernized with radar, 5 inch gun turrets and numerous anti-aircraft mounts, she was a far different ship than the SARATOGA of 1939. MS 21 was effective against aerial observers.**

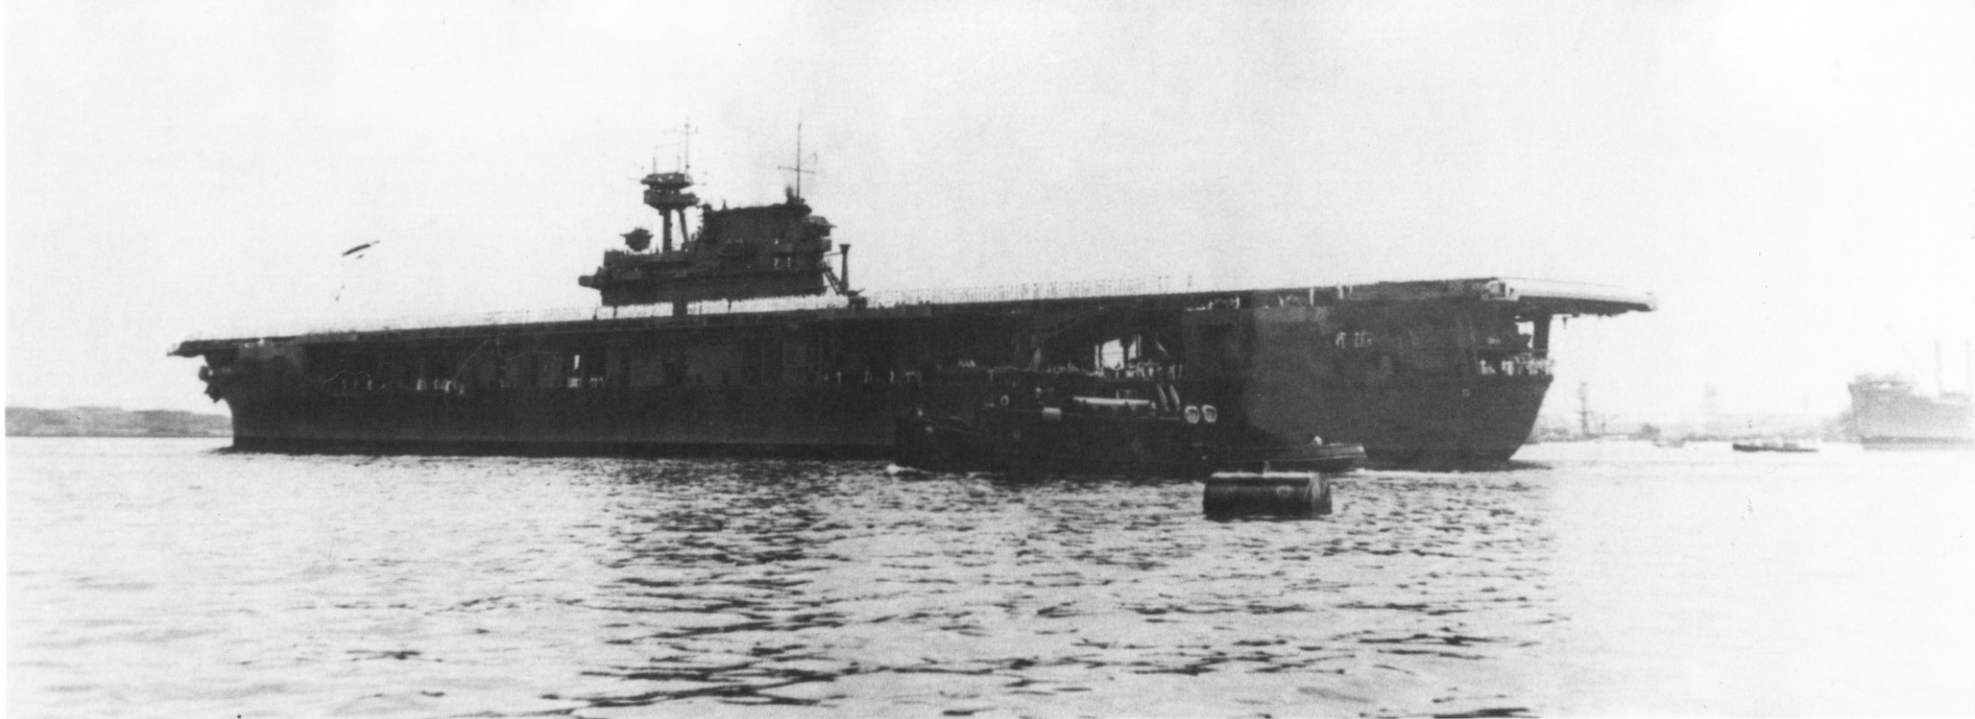
**YORKTOWN** arrives at Pearl Harbor on 27 May 1942. She has a CXAM radar on the foremast and quad 1.1 inch anti-aircraft mounts fore and aft of the island. The AA directors are the lightweight Mk 33s, normally reserved for cruisers. (NHC)

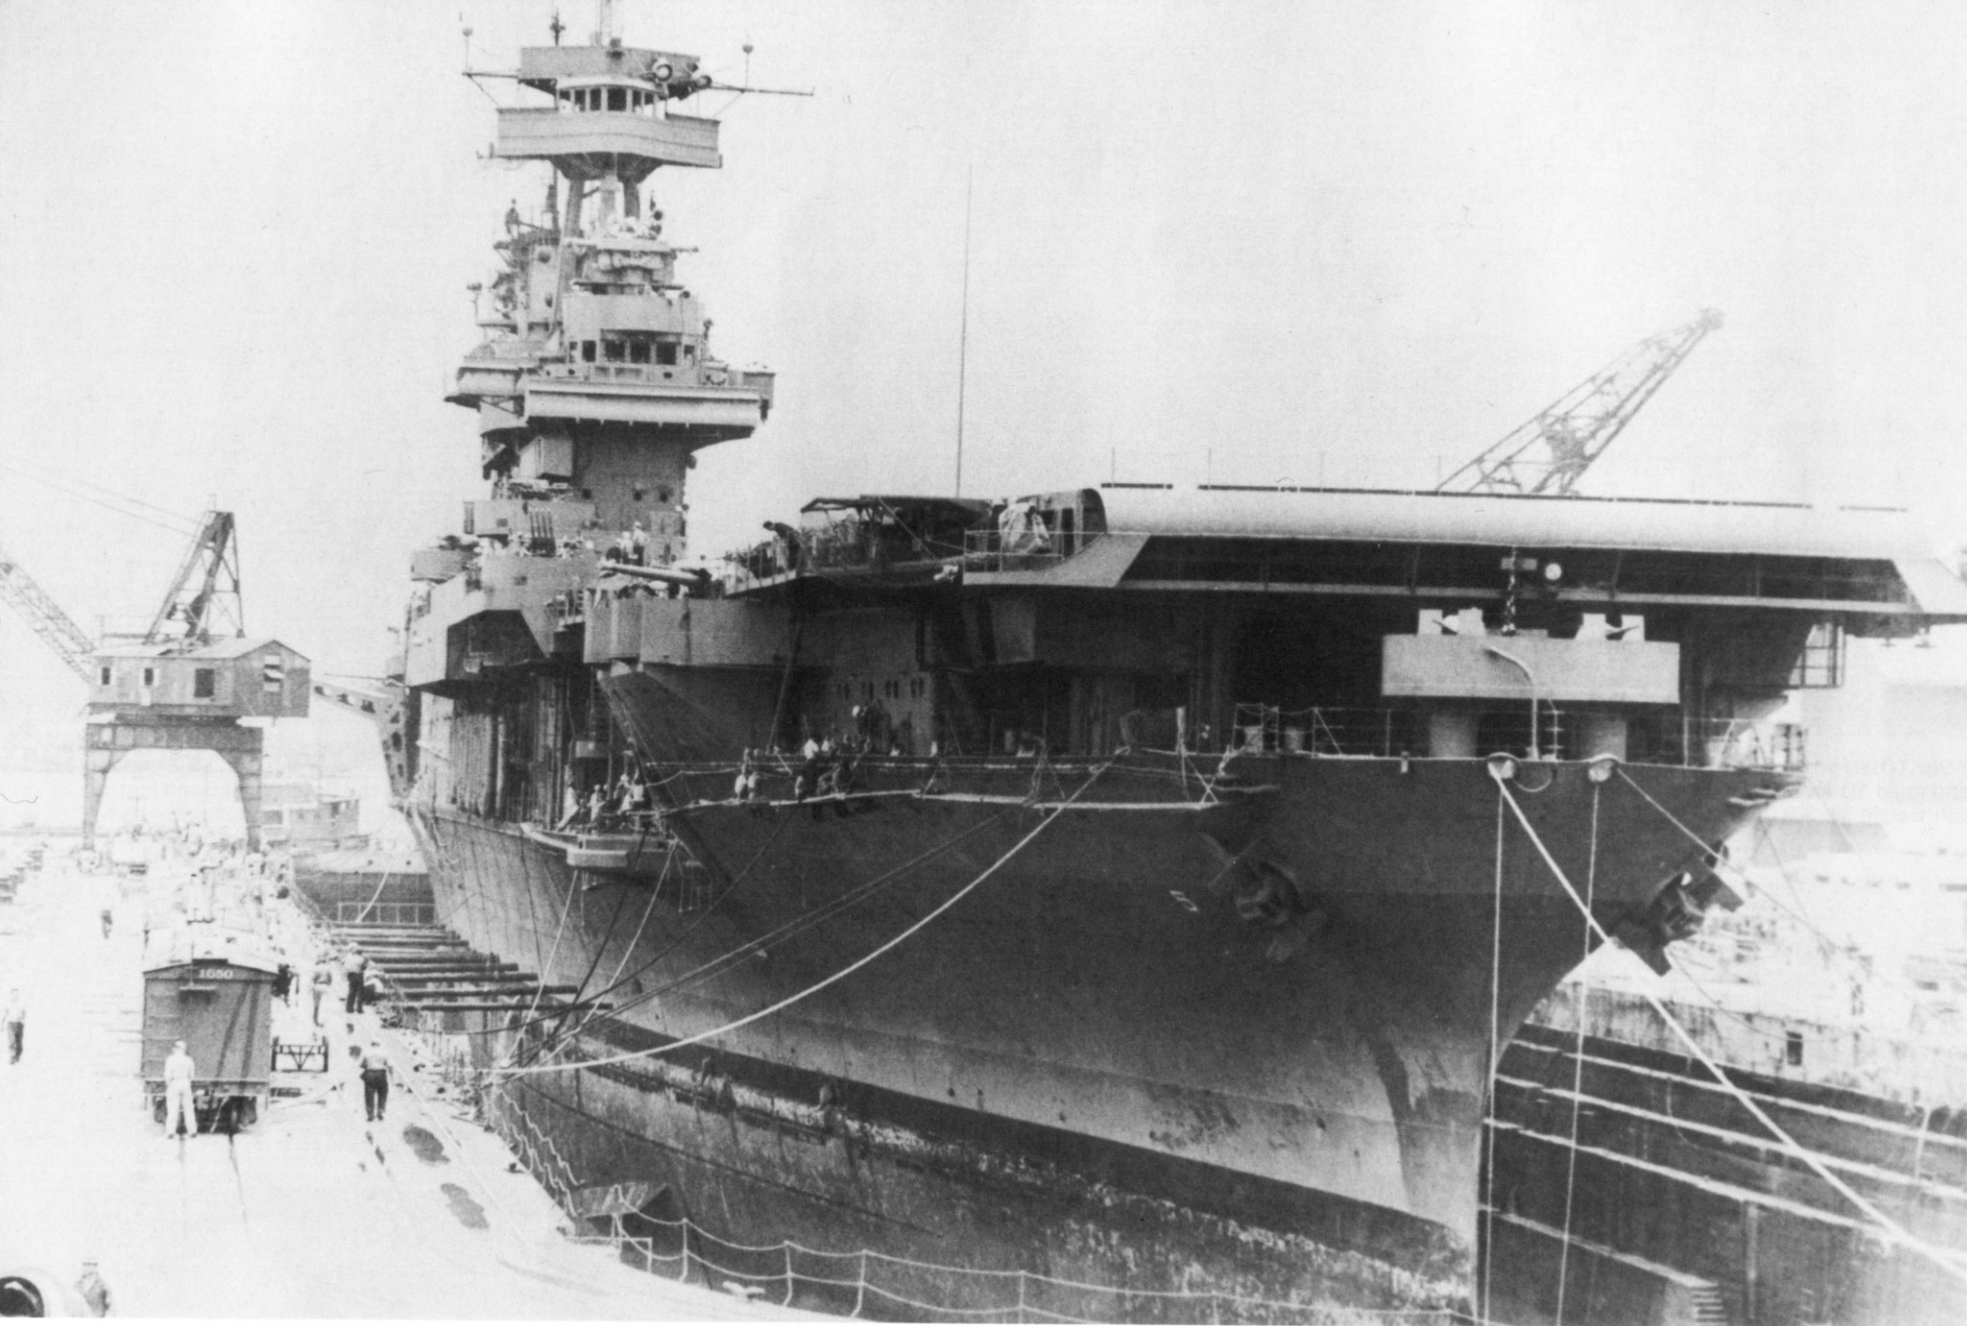
The YORKTOWN rests in dry dock at Pearl Harbor, on 27 May 1942. She suffered considerable structural damage at the Battle of the Coral Sea, and the twenty-four hours she was allowed in dry dock before leaving for Midway was insufficient to repair even the most serious damage. She is painted in standard Measure 12 camouflage. (NARA)

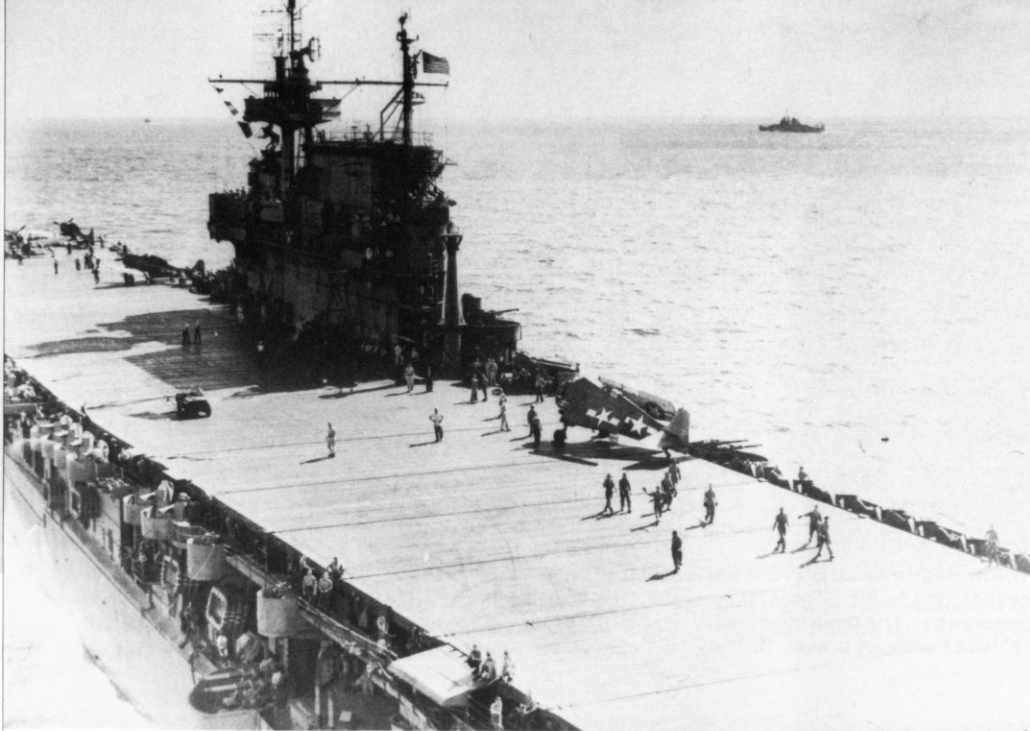
During 1944, the radar suite on ENTERPRISE included SK and SP antennas on her foremast and an SC-2 antenna on a small outrigger abreast the funnel. The aircraft aft the island are Grumman F6F Hellcats. By this time the Hellcat had taken over as the primary carrier fighter. (NARA)

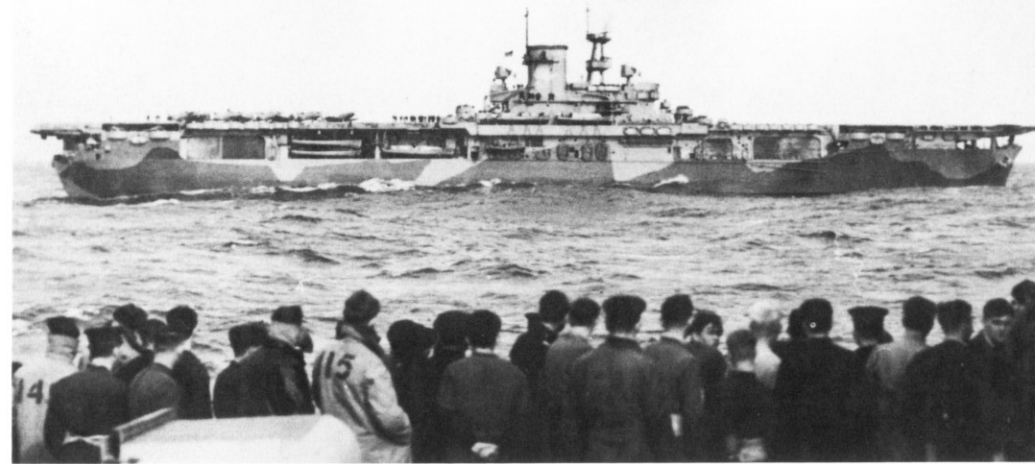
WASP carried a CXAM-1 Air Search Radar and RFD fire control radars on Mk 33 gun directors. WASP had a short operational career, being lost after receiving three torpedo hits on 15 September 1942. (NARA)

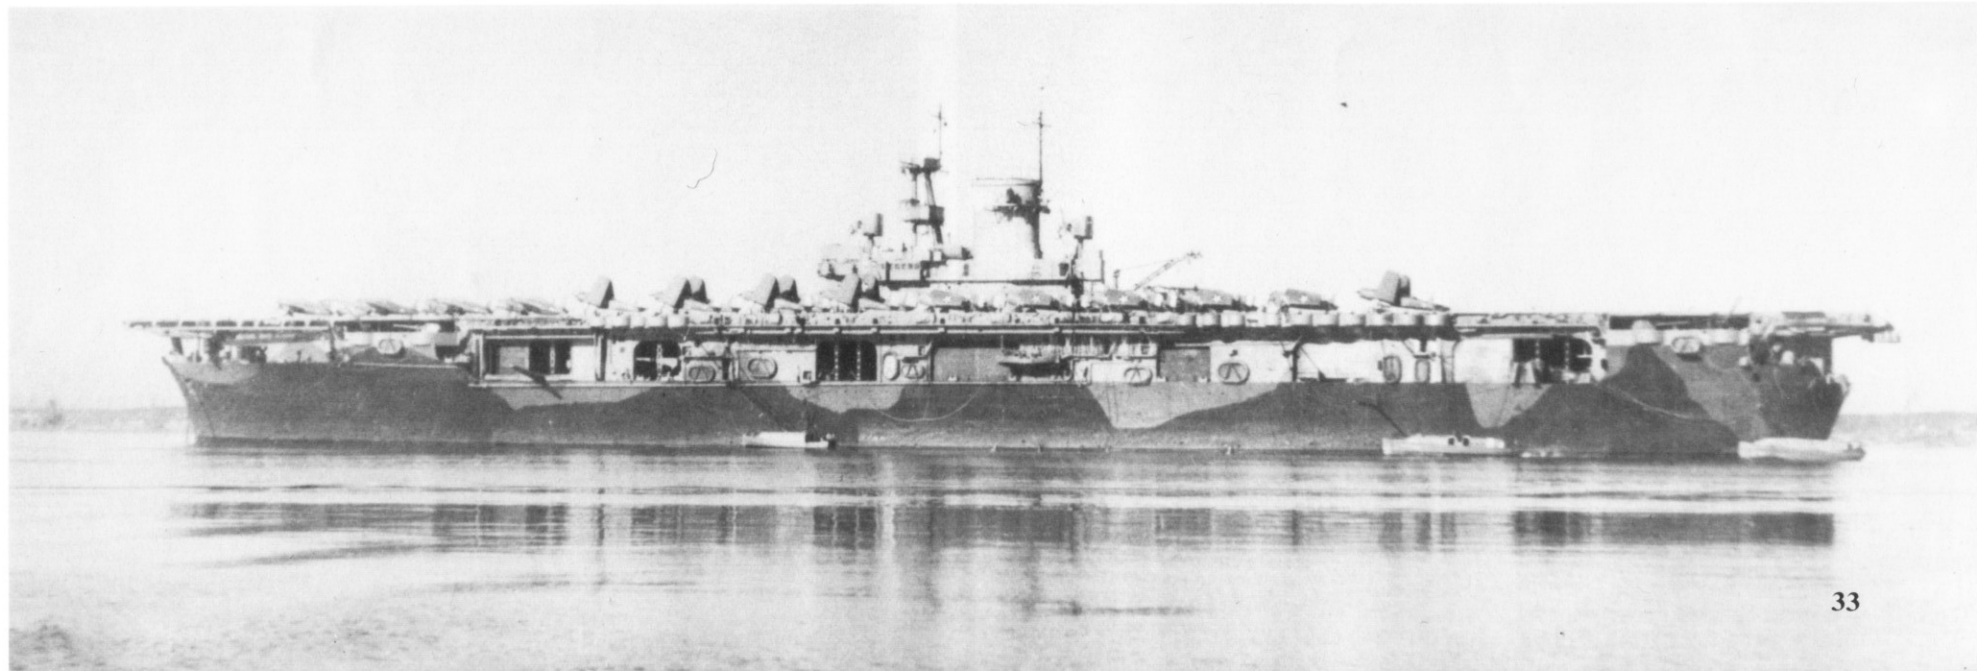
USS WASP at anchor in the Atlantic during March of 1942. She is painted in Measure 12 Mod camouflage. The aircraft with the upward folding wings are SB2U Vindicator scout bombers. (NARA)

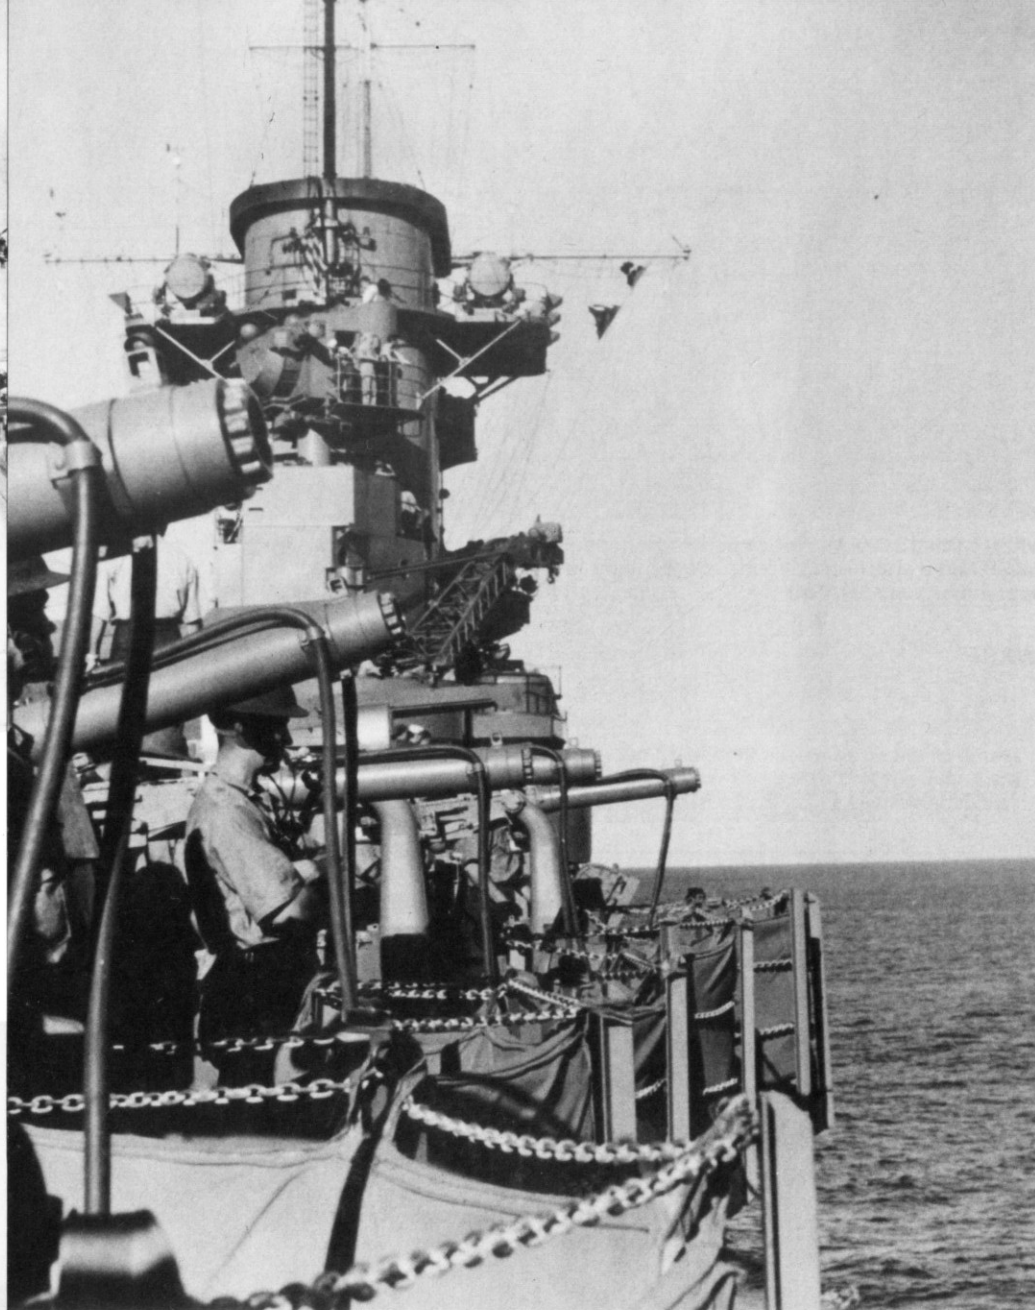
The starboard side of WASP's flightdeck aft of the island was lined with a battery of water-cooled .50 cal. machine guns. The presence of these light AA guns and the old fashioned helmets worn by the gun crew indicate that this was early in the war. By the time WASP entered combat in the South Pacific, these machine guns had been replaced by the slightly more effective 20MM Oerlikon cannon. (NARA)

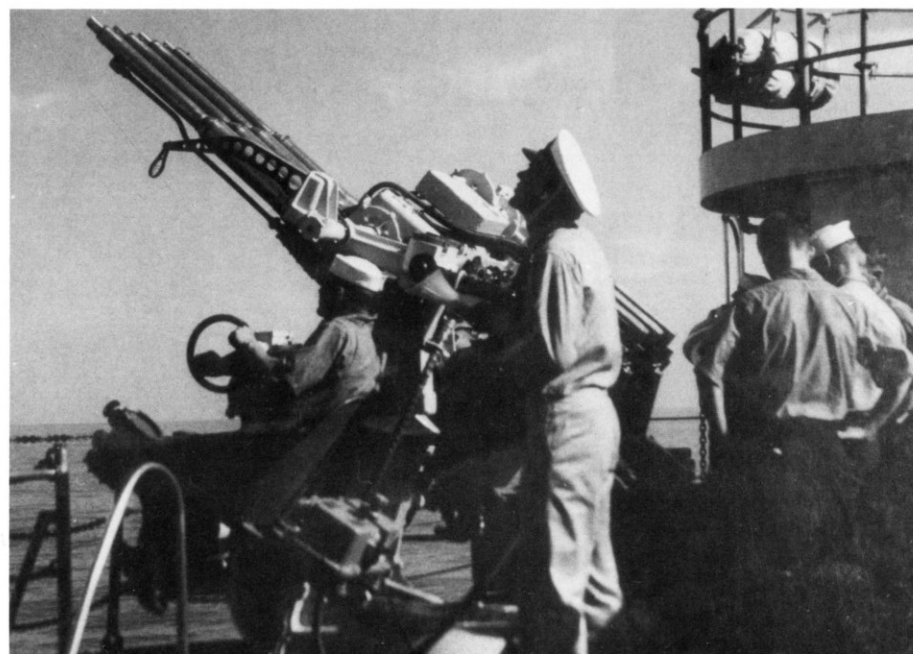
The 1.1" quad mounts fitted to WASP during 1941, proved utterly ineffective in combat, and were replaced by the 40MM Bofors as soon as they became available. (NARA)

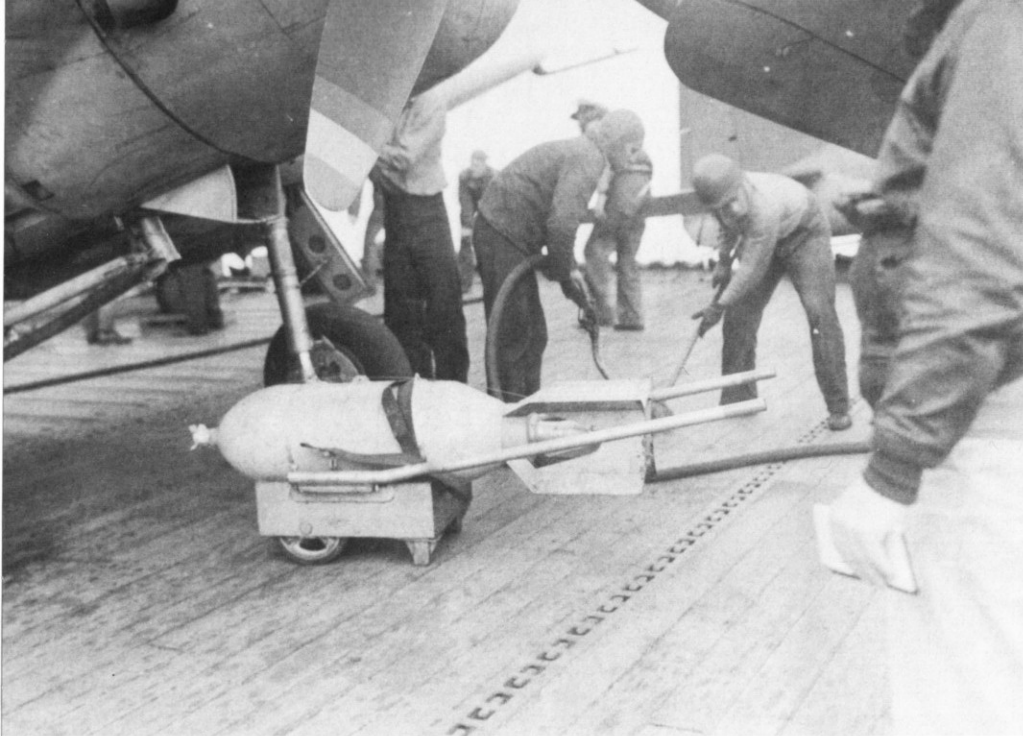
A variety of deck equipment was used to move aircraft and their weapons around the flight deck such as this hand trolley, which was used to move 500 pound bombs from the magazine to waiting Douglas SBD Dauntless dive bombers aboard RANGER, during November of 1942.

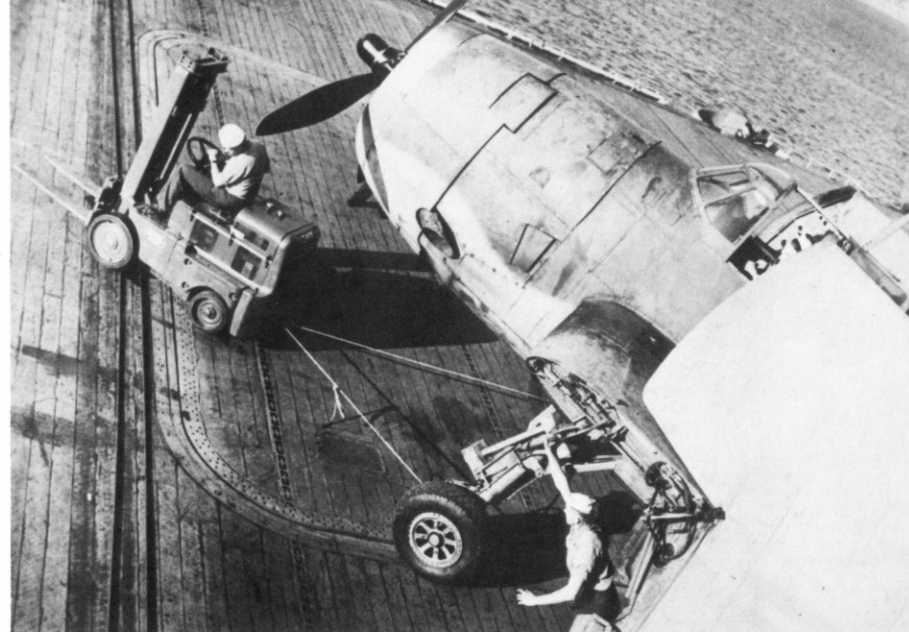
A forklift is pressed into service as an aircraft tractor to reposition this Avenger on 19 November 1943. Instead of a tow bar, ropes were attached to the main landing gear.

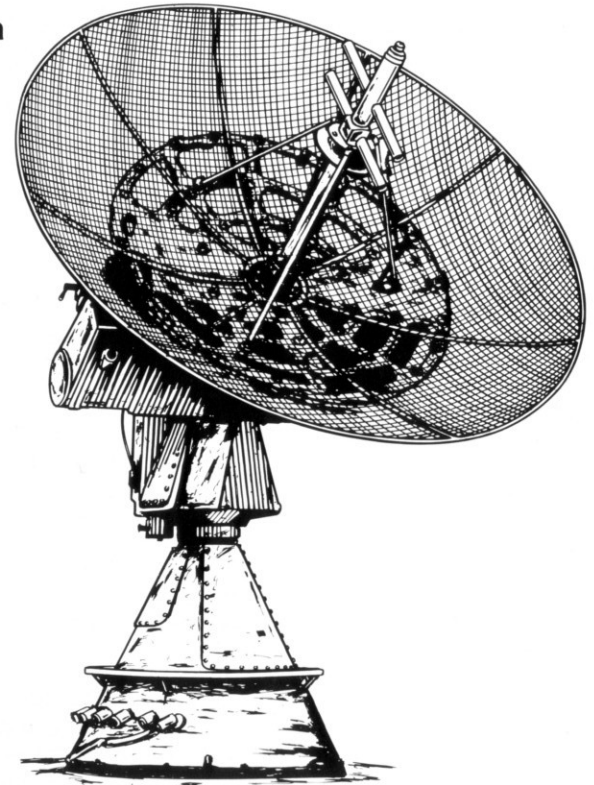
## SM Radar Antenna

The obvious solution was narrow beam radar mounted so as to scan vertically as well as rotating. The first of these was the SM (originally CXBL) which first was mounted on U.S. aircraft carriers during 1943. SM was an S-band radar fitted with an eight foot diameter circular dish antenna. The SM's mounting was heavy, restricting its use to fleet carriers. Later, it was superseded by the smaller SP radar with a six foot diameter antenna. Both of these antennas appeared in a variety of forms: they could be full circles or circles with an arc section removed at the bottom or both bottom and top. Also, they were almost always fitted with the dipole antennas of the BO IFF system, which could be mounted on three parallel vertical rails mounted in front of the dish, on a separate mattress antenna mounted above the dish or both.

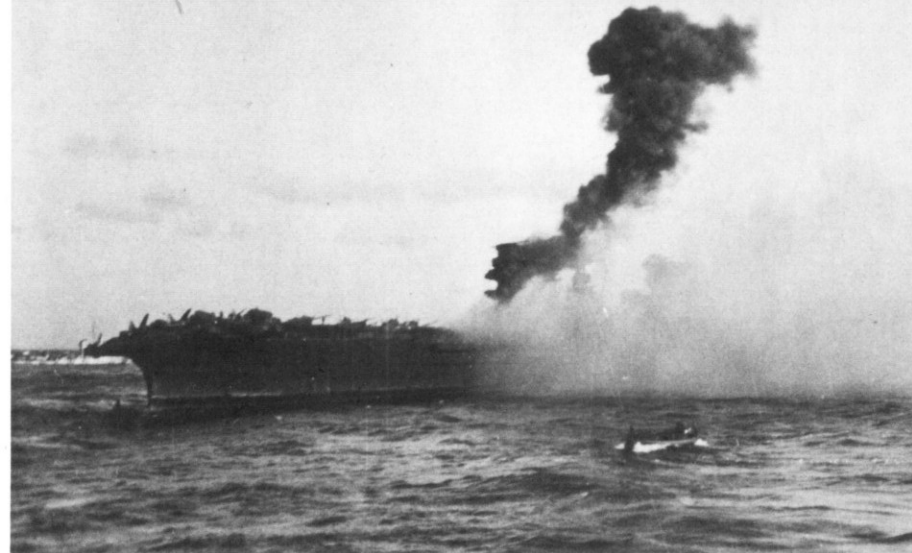
**A mushroom cloud rises over LEXINGTON after an AVGAS (Aviation Gasoline) explosion ripped through her hull. The damage from the Japanese bombs and torpedos was not fatal in itself, but once the leaking AVGAS caught fire, her fate was sealed. (NHC)**

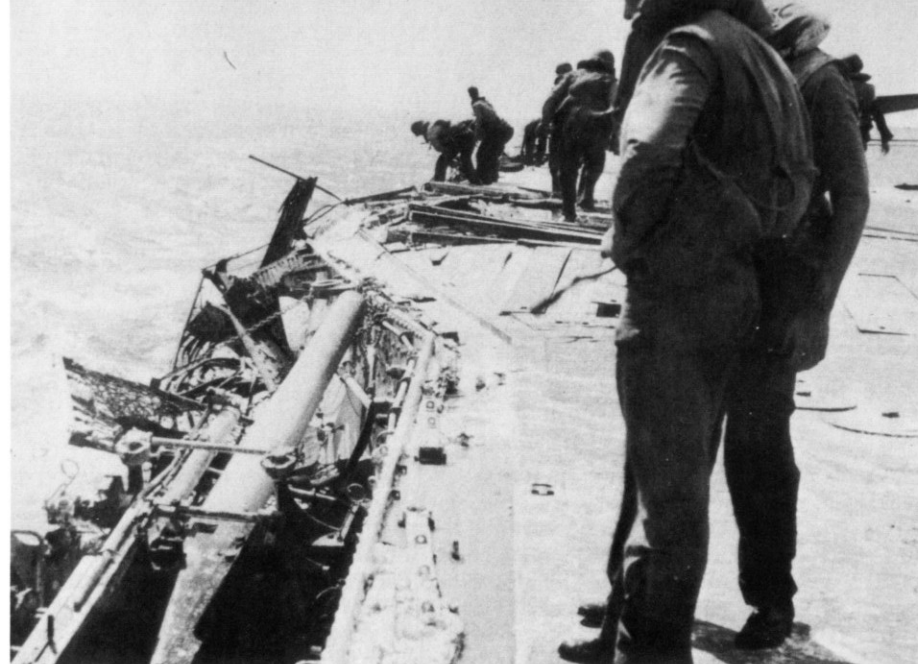
Crewmen on LEXINGTON survey the damage done to the port forward 5" gun battery by one of the few Japanese bombs to hit LEXINGTON at Coral Sea on 8 May 1942. The bombs caused only minor damage, however, the main damage was done by a single torpedo hit forward. (NARA)

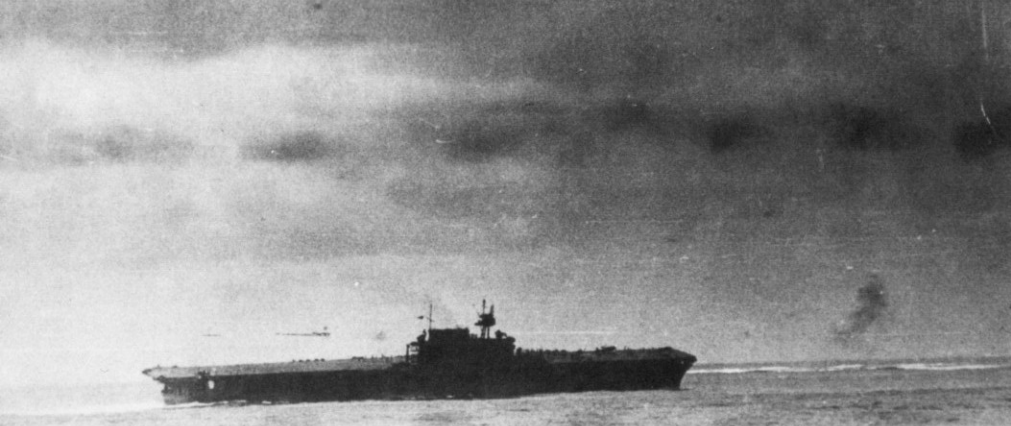
Maneuvering violently, in a largely successful attempt to avoid Japanese bombers, ENTERPRISE pitched steeply to starboard. The maneuver caused a Douglas SBD Dauntless to slip into the starboard gallery aft. (NARA)

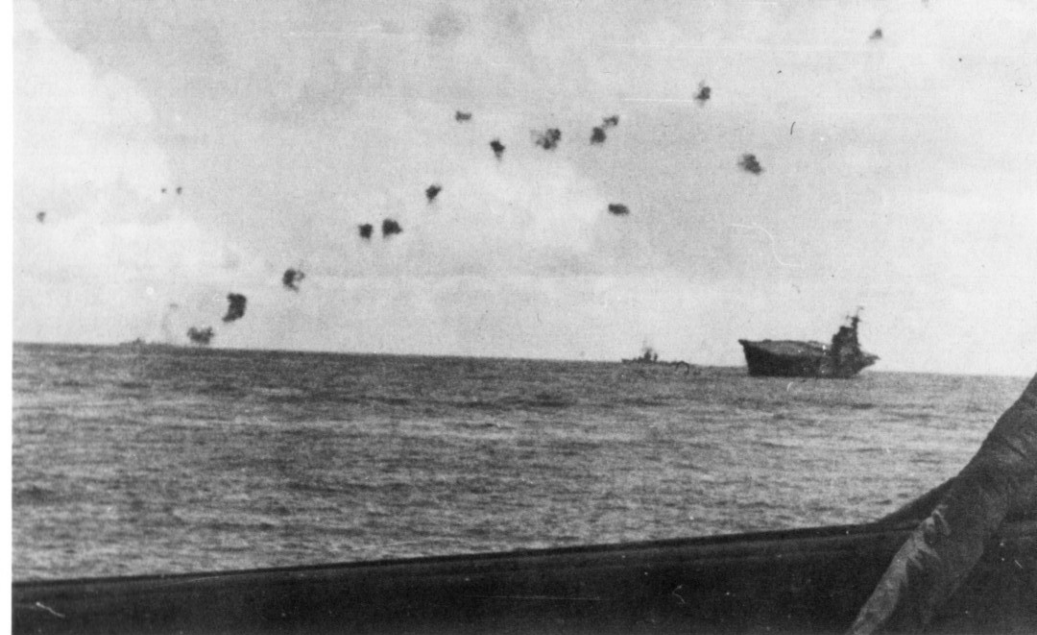
**While HORNET was successfully fighting the damage caused by two torpedos and at least five bomb hits, she fell victim to a single additional torpedo hit from an attack by nine Kates. The additional damage was enough to doom the carrier. (NARA)**

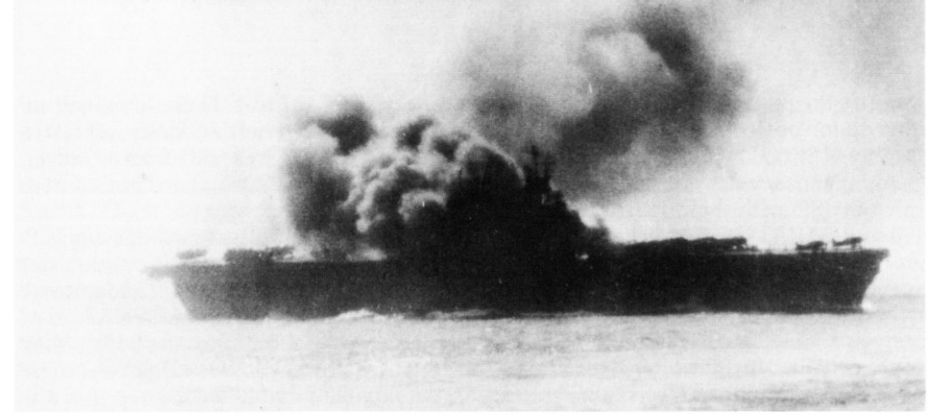
**ENTERPRISE was hit by a single bomb on 20 March 1945, during raids on the Inland Sea. As the fast carrier task forces drew closer to Japan, the intensity of the defense, both conventional and kamikaze, grew. Although the damage was minor, ENTERPRISE was hit again in May and finally driven out of the war. (NARA)**

ENTERPRISE continued in action without SARATOGA, hitting Tokyo again on 25 and 26 February and Okinawa on 1 March. On 14 March, ENTERPRISE again sortied from Ulithi, now part of TG 58.2 with FRANKLIN. On 18 March, while attacking Kyushu, ENTERPRISE was slightly damaged by kamikazes. On the next day, FRANKLIN was hit by Japanese bombers and again severely damaged. ENTERPRISE was also hit, but the damage was minor. On 29 March, ENTERPRISE was assigned to TG 58.4, along with the new YORKTOWN, INTREPID and LANGLEY, with the task of continuing the aerial assault on Okinawa in preparation for the upcoming invasion. She was hit by kamikazes again on 11 April, this time seriously enough to require repairs at Ulithi. She was back off Okinawa again on 3 May, as part of TG 58.4. When the rest of that group retired on Ulithi on 10 May, ENTERPRISE transferred to TG 58.1, joining the new HORNET, BENNINGTON, RANDOLPH, BELLEAU WOOD and SAN JACINTO. The next day BUNKER HILL was seriously damaged by kamikazes, causing ADM Mitscher, now in charge of TF 58, to transfer his flag to ENTERPRISE. On the 12th and 13th, the entire task force raided the kamikaze airfields on Kyushu, trying to suppress these increasingly damaging attacks. On 14 May, having tempted fate perhaps once too often, ENTERPRISE was again hit by kamikazes, this time seriously. The damage was severe enough to send her back to the West Coast for repairs.

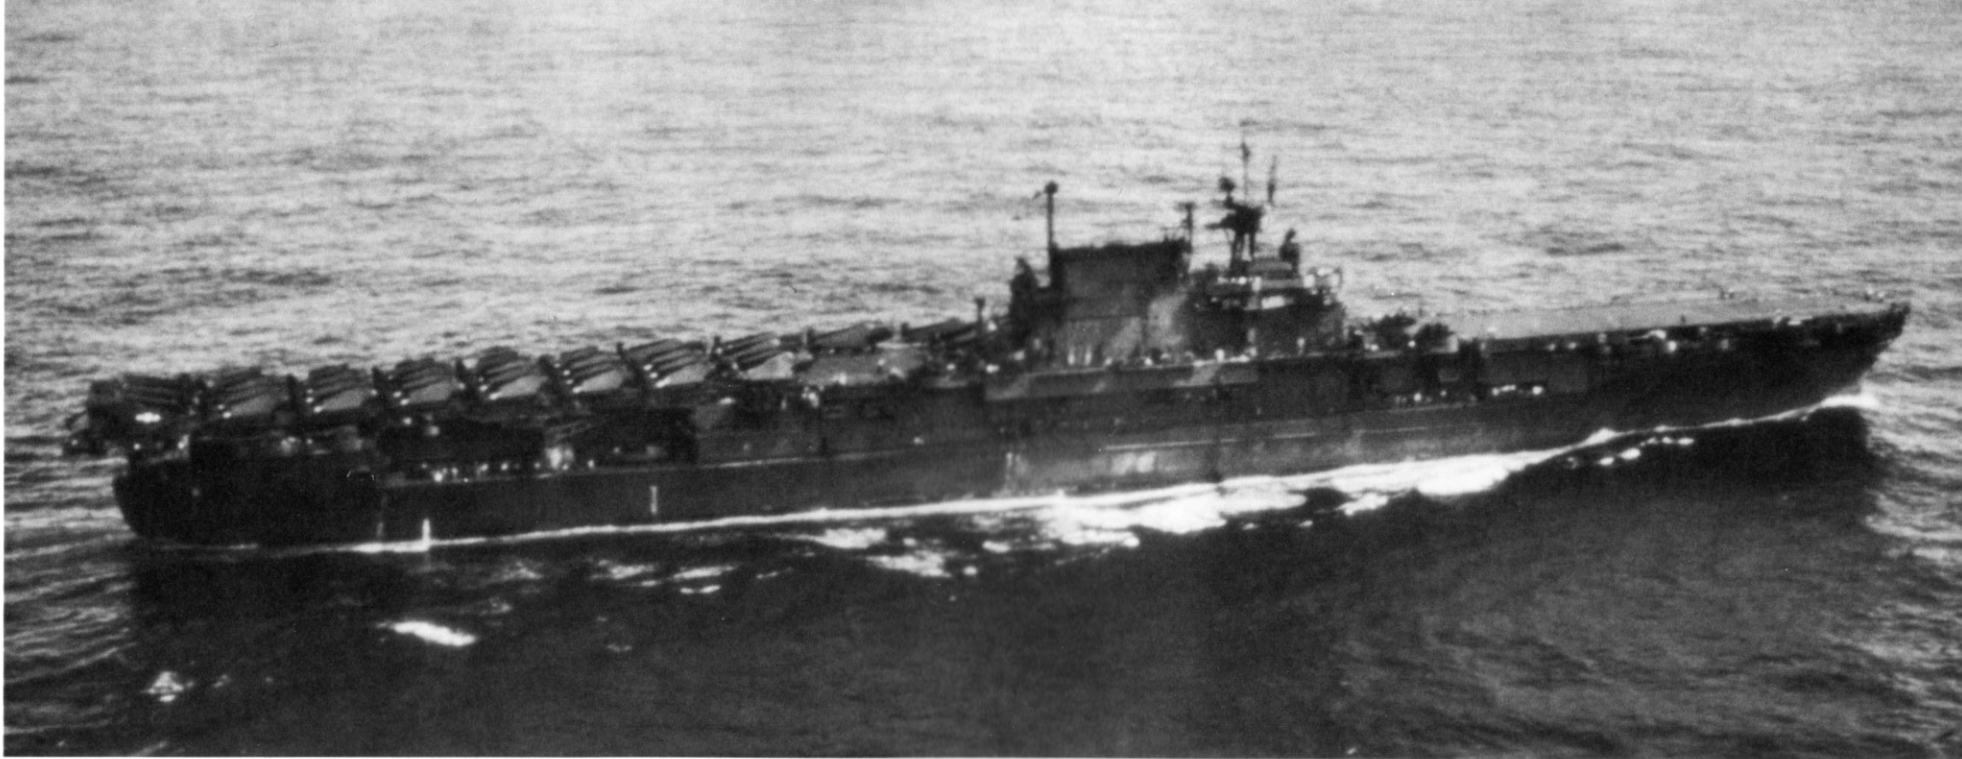
**USS ENTERPRISE** steams at high speed with a full deckload of aircraft. It was normal practice for U.S. carriers to carry their air wing on deck, using the hangar deck strictly for maintenance rather than storage. (NARA)

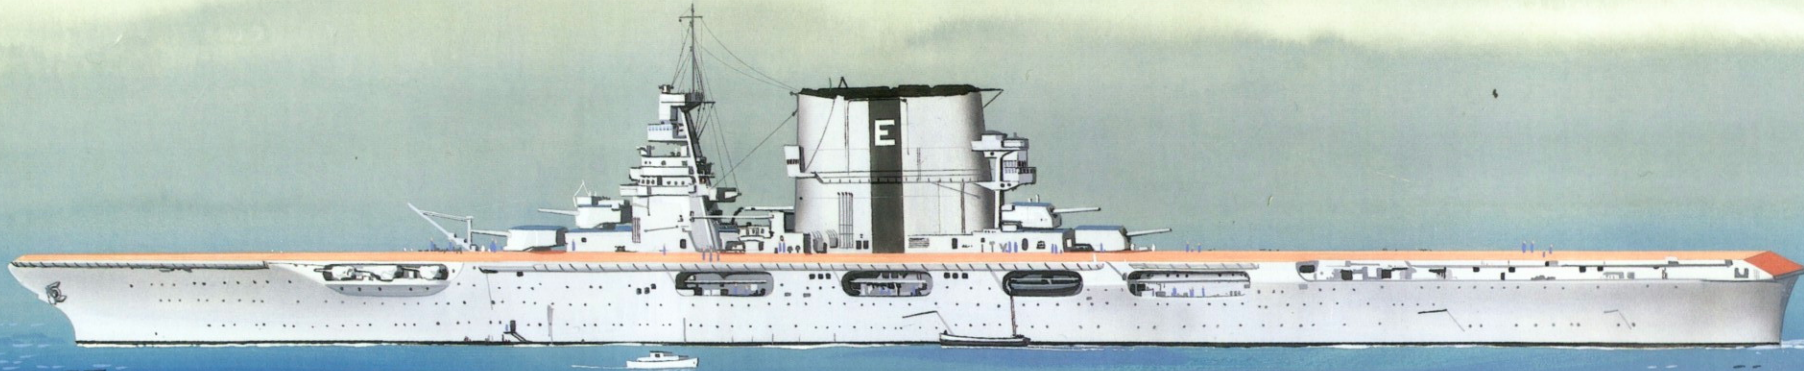
USS SARATOGA (CV3) carried a Black bar on the funnel as a recognition aid to identify her from her sister ship USS LEXINGTON (CV2).

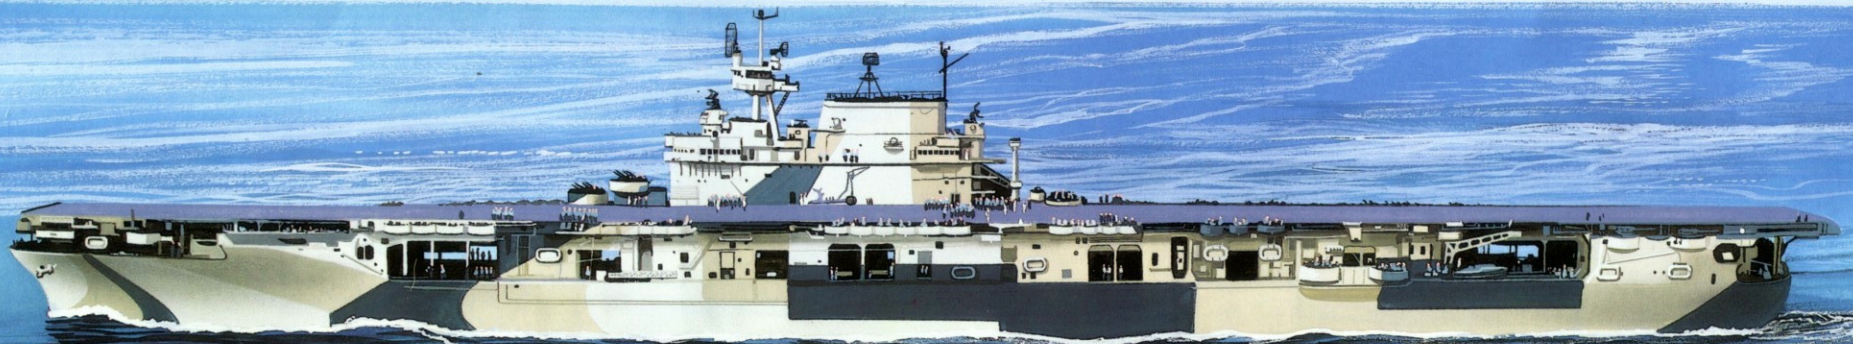
USS ENTERPRISE (CV6) during late 1944. ENTERPRISE was broken up during 1956, despite efforts to preserve her.
